THE TRIPLE WIN: Healthier Air, Lower Energy Costs, and Greater Comfort

A Case Study

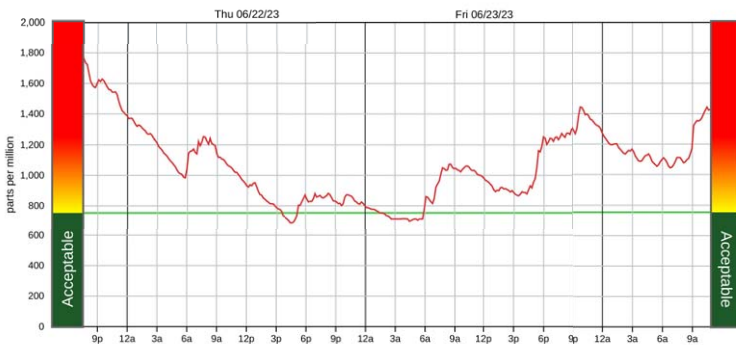
BEFORE

Highest Daily Average: 1557 ppm
Highest Hourly Average: 1622 ppm
Overall Average: 1063 ppm

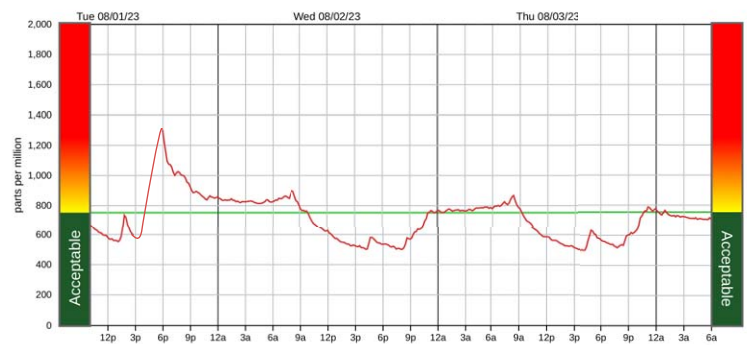
AFTER

Highest Daily Average: 801 ppm
Highest Hourly Average: 1151 ppm
Overall Average: 702 ppm

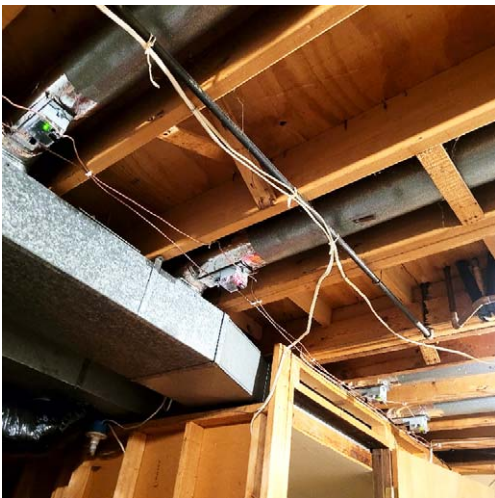
(Left) Custom zoning controls were installed in the ductwork to control the flow of air through different zones.

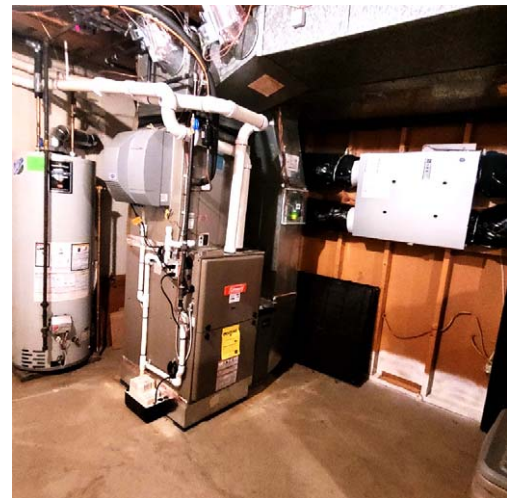
(Right) A heat recovery ventilator was hung on the wall to the right of the furnace.
